IN-SERVICE RESULTS FROM ESKOM DISTRIBUTION LINES: BPS PRODUCED “SUPERPOLES”

Albin AW Baecker, Biotrans Africa CC

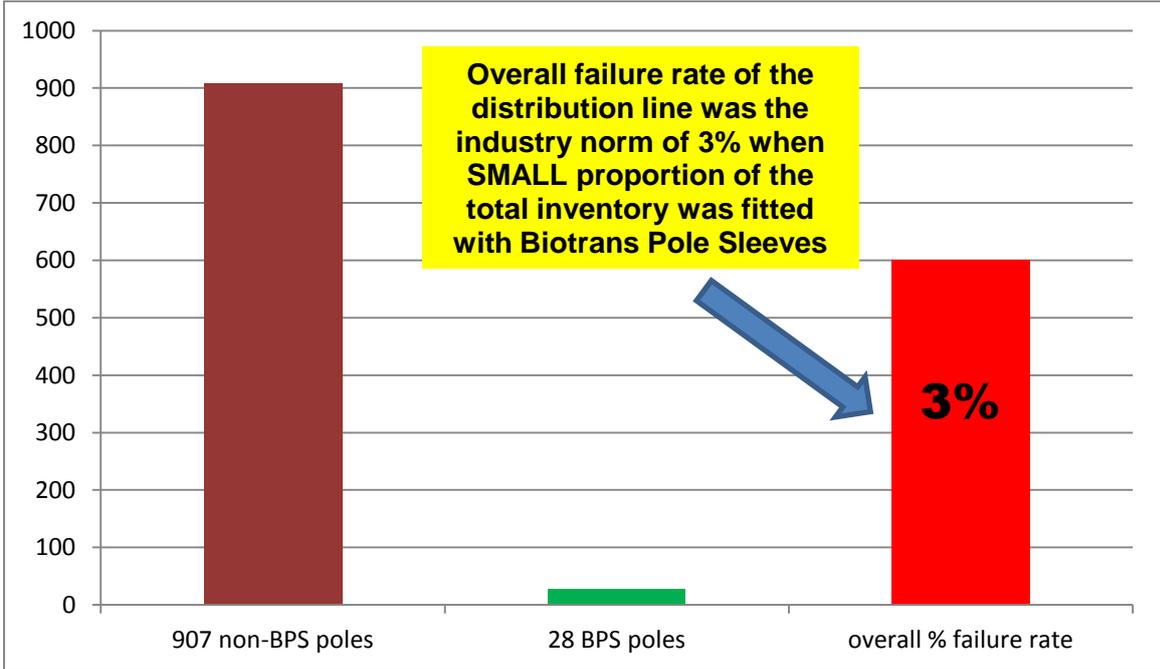
Figure 1a: Eskom-approved inspectors' findings in 2005 on Richmond Beaumont NB 63 distribution line after 10 years' service: overall failure rate among all 935 poles was 3% (although the failure rate among the 28 BPS poles was 0%)

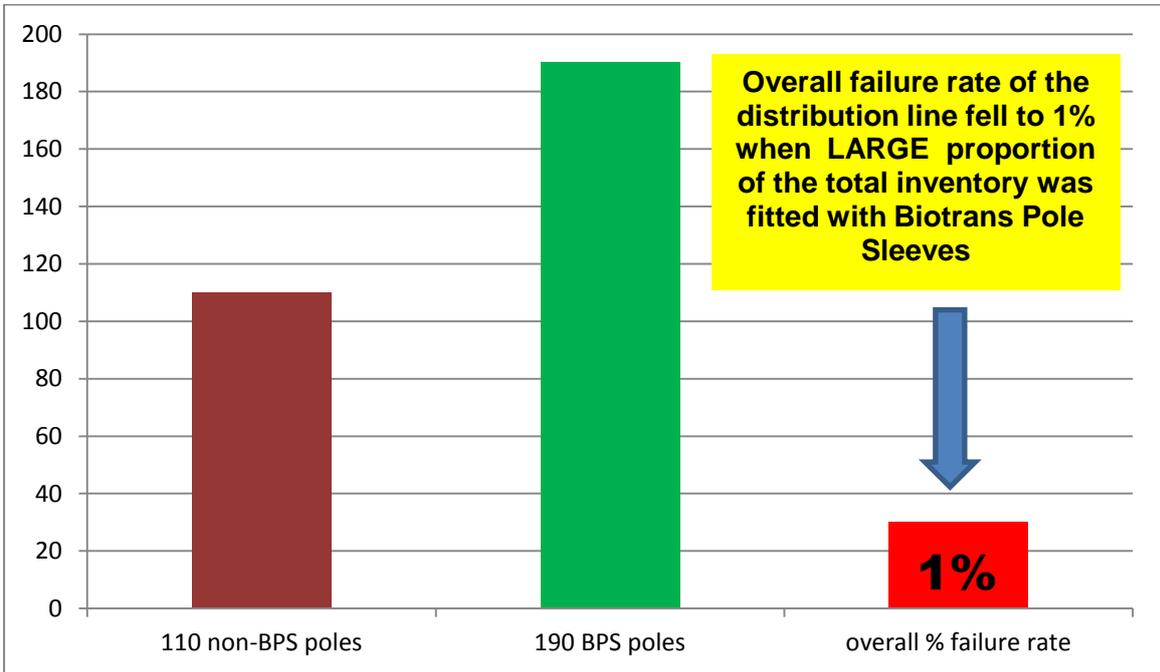
Figure 1b: Eskom-approved inspectors' findings in 2005 on Richmond Beaumont NB 22 LV distribution line after 10 years' service: overall failure rate among all 300 poles was 1% (although the failure rate among the 110 non-BPS poles was the normal 3% while among the 190 BPS poles only 1 of them had not become a Class 1 pole)
