# A REVIEW OF FOUR LONG-TERM IN-SERVICE PERFORMANCE STUDIES OF ELECTRICITY DISTRIBUTION POLES FITTED WITH BARRIER PROTECTION SYSTEMS

Albin AW Baecker  
Baecker Research, Thornville, South Africa

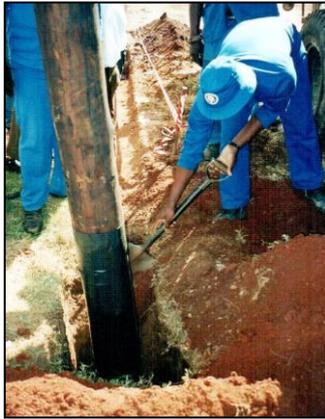
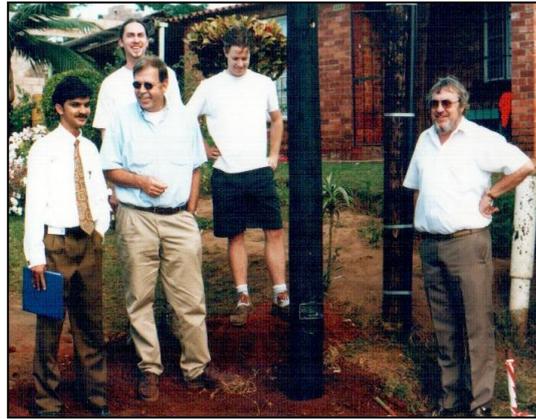
**Fig. 1** The first utility pole with BPS was (a) installed in RSA by eThekweni Electricity (b) in 1994

The first in-service utility pole fitted with a prototype multilayer BPS was installed by eThekweni Electricity in 1994 (**Fig. 1**) and, after successful performance in South Africa was confirmed, BPS were introduced by Seattle City Light (SCL) in 1999. After three years of tests by that utility the BPS was specified in 2002 for use on all poles installed by it thereafter (**App. 1**), and neighbouring Puget Sound Energy Services decided to install poles with BPS in environmentally sensitive areas such as the banks of salmon rivers. Subsequent independent laboratory trials (Morrell *et al*, 2006) and in-field inspections of SCL's distribution lines by the specialist pole unit of Oregon State University (OSU) in 2007 confirmed that poles with BPS that had been in service for eight years were in perfect condition below the ground line (**Fig. 2**). Indeed, this writer was present when all the present photographs were taken and the comment of the widely experienced inspector (Ms. Connie Love, *pers. comm.*, 2007) when the surface of the first SCL pole was exposed for inspection in 2007 was, "I have never seen poles in such good condition below the groundline."

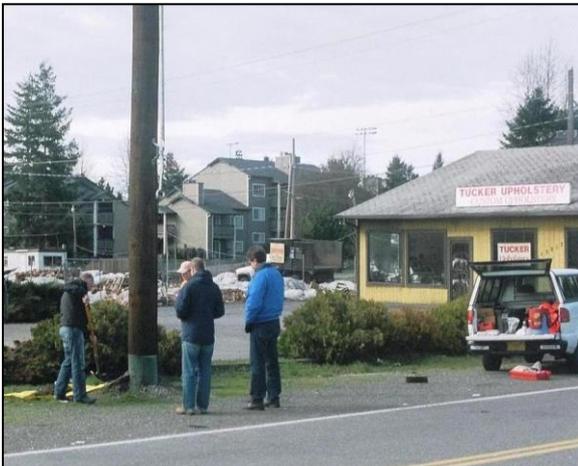
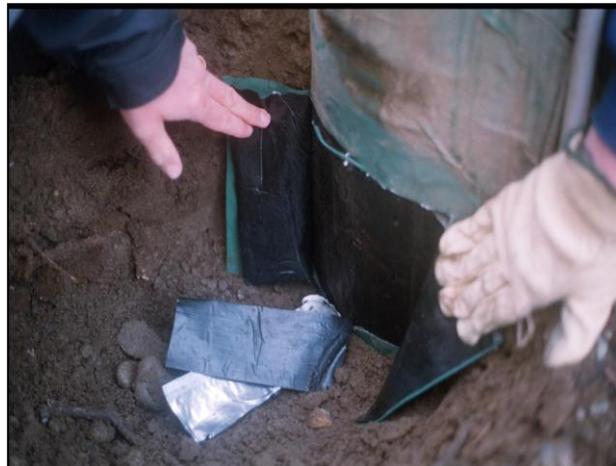
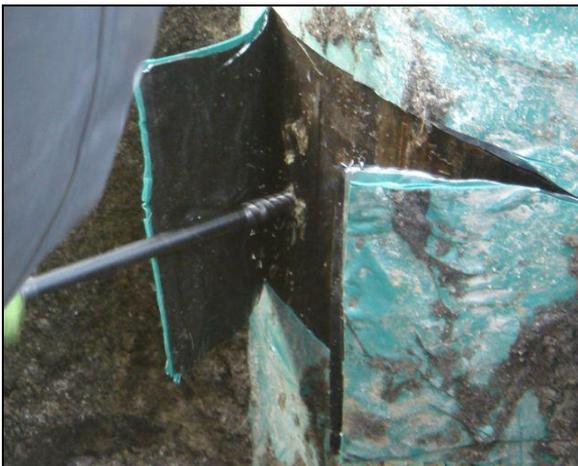
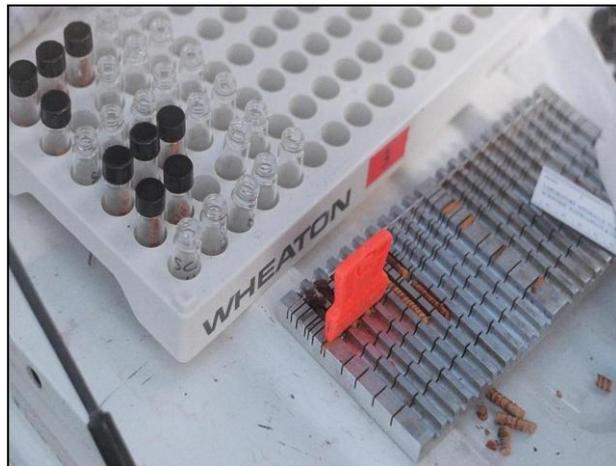
**Fig. 2** When utility poles with BPS in Seattle were inspected by OSU pole experts (a) after 8 years' service in 2007 all subsoil surfaces of the poles (b) were revealed to be in perfect condition. All samples (c) were stored in the mobile laboratory (d) before transport to OSU to analyse them for preservative retention and moisture content.

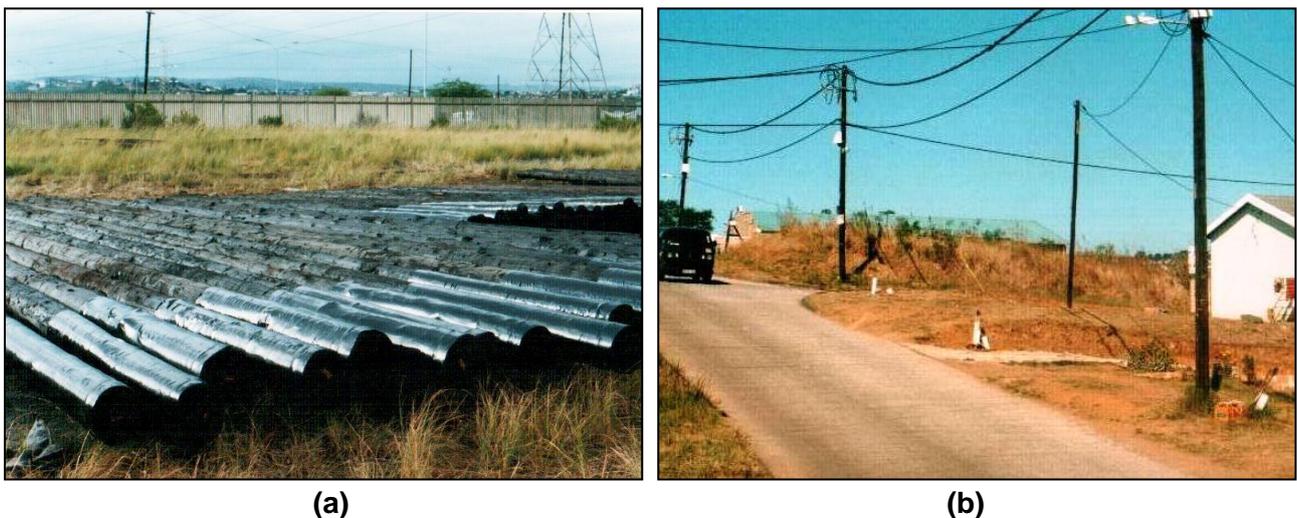
**Fig. 3** Utility poles with BPS at eThekweni Electricity's Springfield pole yard in 1995 (a) before installation (b) on electricity distribution line in Newlands West, Durban

**Commencement.** The BPS prototypes for utility poles were multilayered heat shrink sleeves and they were installed by eThekweni Electricity in 1995 (Fig. 3), by Eskom at Umbumbulu in 1995 (Fig. 4), and by Ekurhuleni Electricity in 1997 (Fig. 5). Several more installations were made by

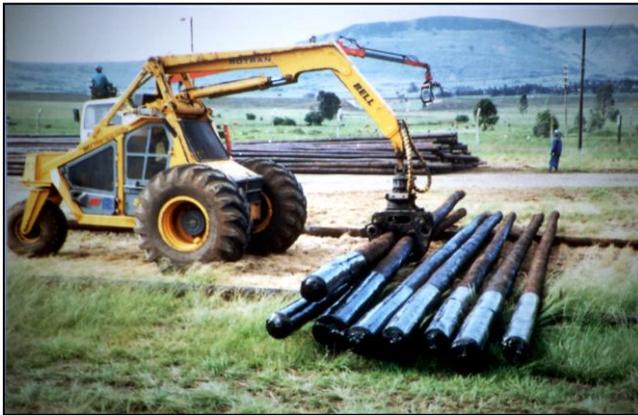
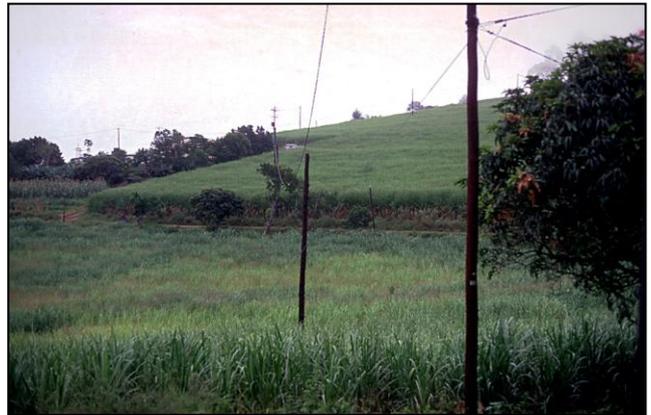
**Fig. 4** Utility poles with BPS at Eskom's Vryheid pole yard in 1995 (a) before installation (b) on electricity distribution line in Umbumbulu

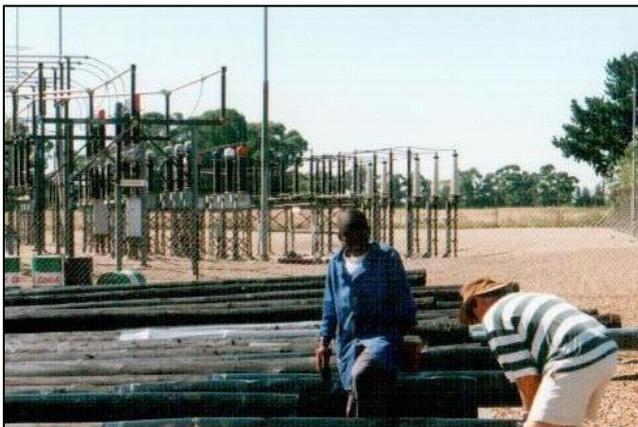
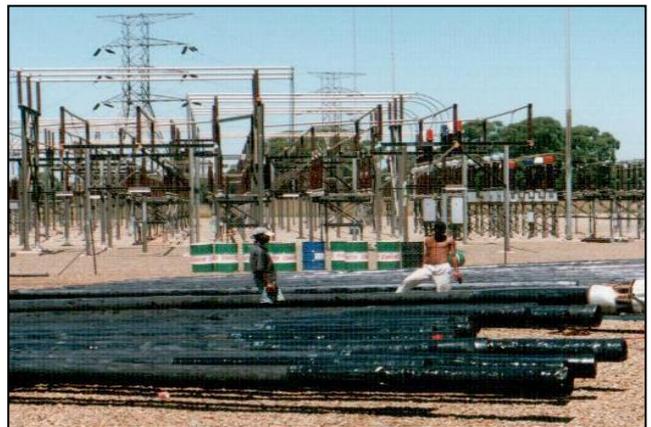
**Fig. 5** Utility poles with BPS being fitted (a) at Ekurhuleni Electricity's Benoni pole yard (b) before installation on electricity distribution line in 1997

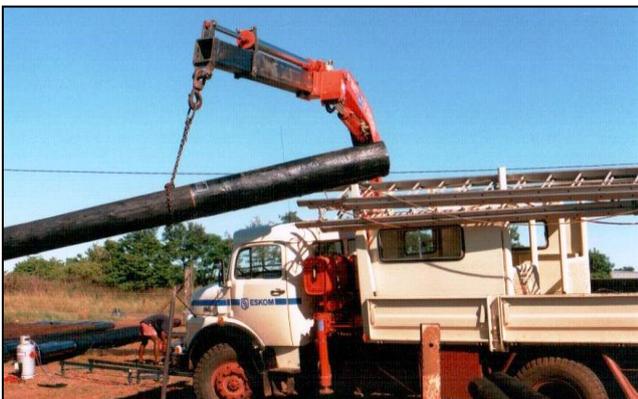
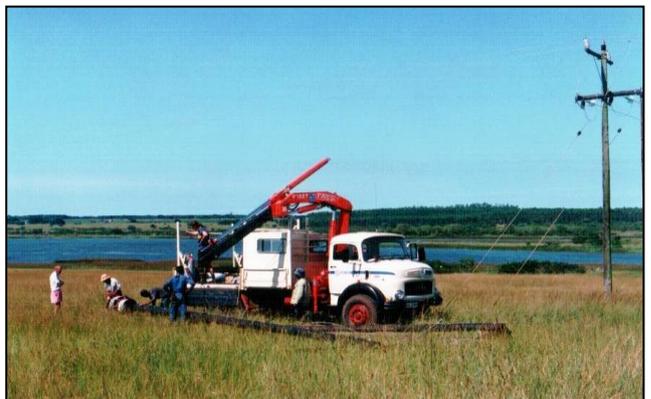
**Fig. 6** Utility poles with BPS at Eskom's Hluhluwe pole yard in 1999 (a) before installation (b) on local electricity distribution line

eThekweni Electricity around Durban, by Ekurhuleni Electricity in 1998, and by Eskom on distribution lines at Hotazel and at Hluhluwe in 1999 (Fig. 6).

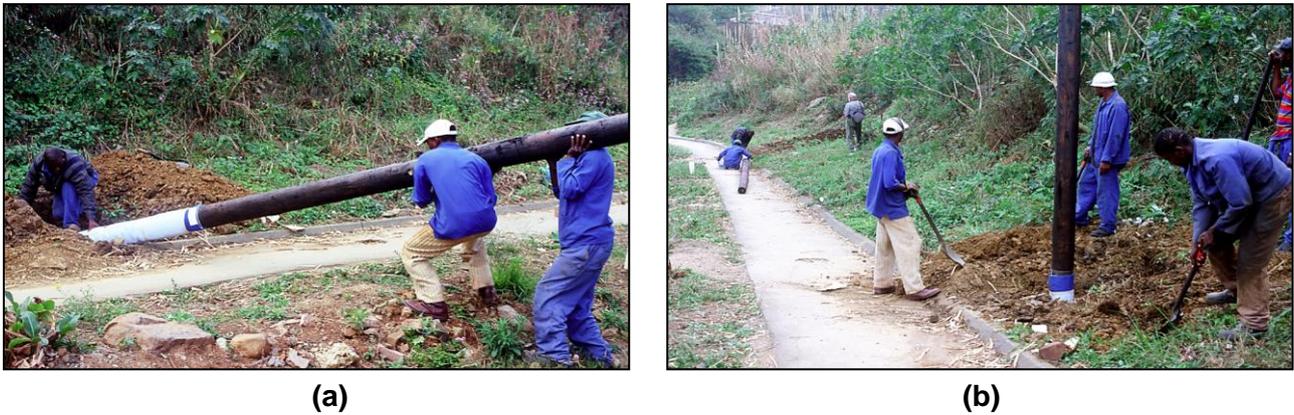
**Fig. 7** Utility poles with BPS (a) being installed on an eThekweni Electricity distribution line (b) in Durban in 2001

**Completion.** After several years of positive results from inspections of the utility poles with BPS at Umbumbulu Eskom requested (Mr. Phil. Crowdy, *pers. comm.*, 1998) that ready-to-use BPS be introduced. Ekurhuleni Electricity and eThekweni Electricity each installed distribution lines using strap-on BPS in 1999 and 2000 respectively (**Fig. 7**). The ready-to-use design was finalised

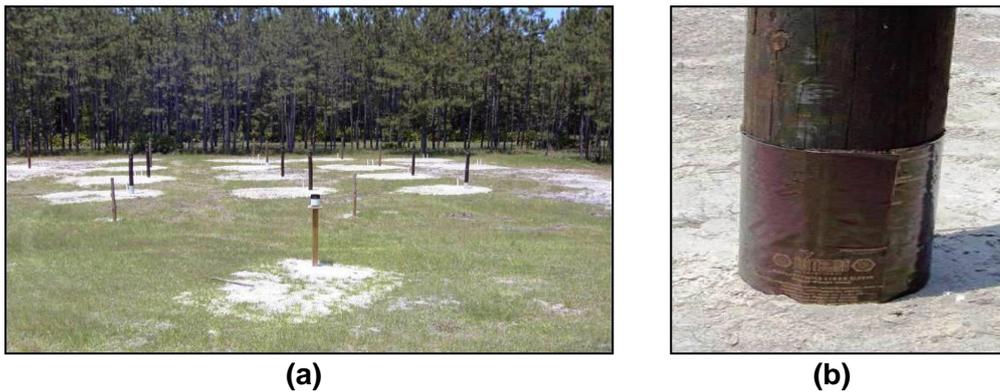
**Fig. 8** Poles at EPRI test site in Gainesville USA (a) with wraparound BPS in 2003

in conjunction with that work and also with field trials conducted by the Electric Power Research Institute (EPRI) in the United States of America (**Fig. 8**) when in 2003 the commercially-available wraparound BPS known as the Biotrans Pole Sleeve was introduced with Snohomish Public Utility

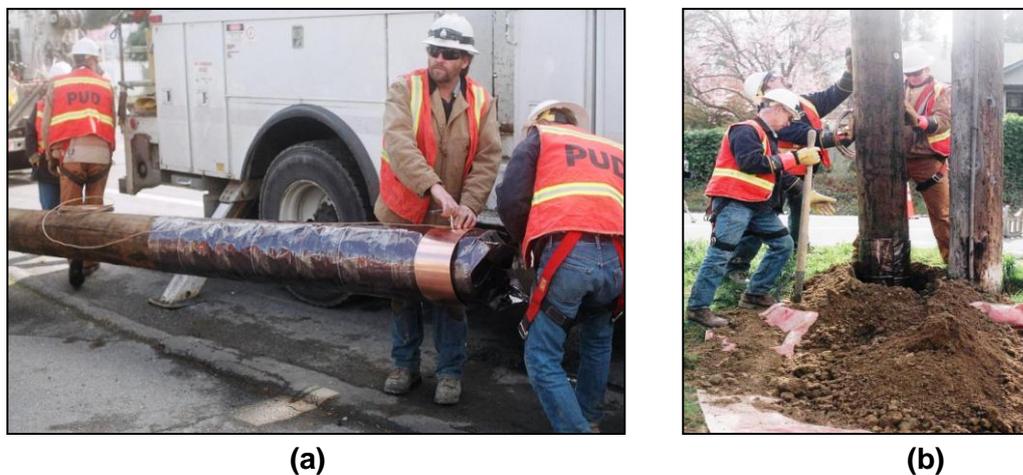
**Fig. 9** Poles with BPS (a) being installed on a SNO-PUD distribution line (b) in Snohomish in 2003

Department (SNOPUD) also in the United States (**Fig. 9**), and also with Kenya Power and Lighting Company (KPLC) in Africa (**Fig. 10**). In South Africa, eThekweni Electricity and Buffalo City Electricity were also supplied with the wraparound BPS in 2003 and Buffalo City installed distribution lines using it in 2004.

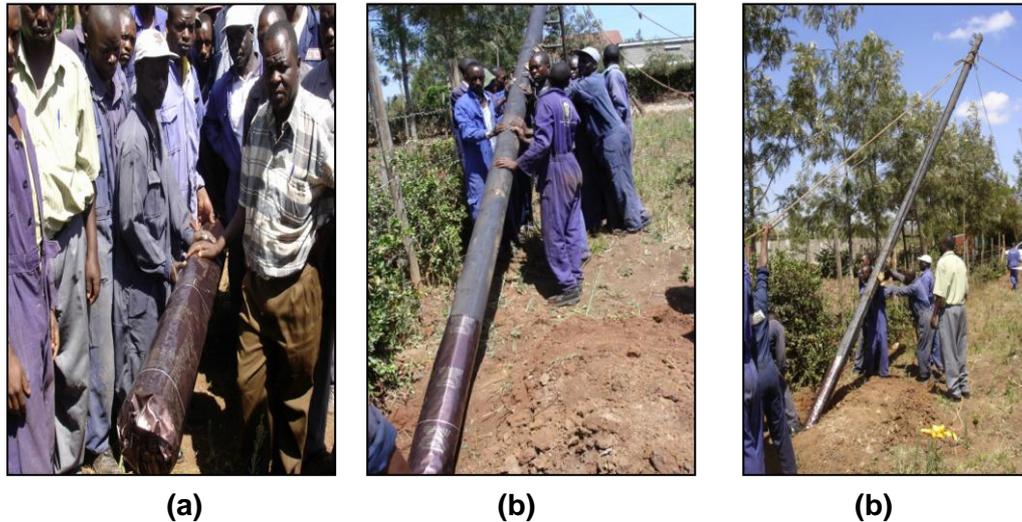
**Fig. 10** Poles with BPS (a) being installed (b) on a KPLC distribution line (c) in Nairobi in 2003

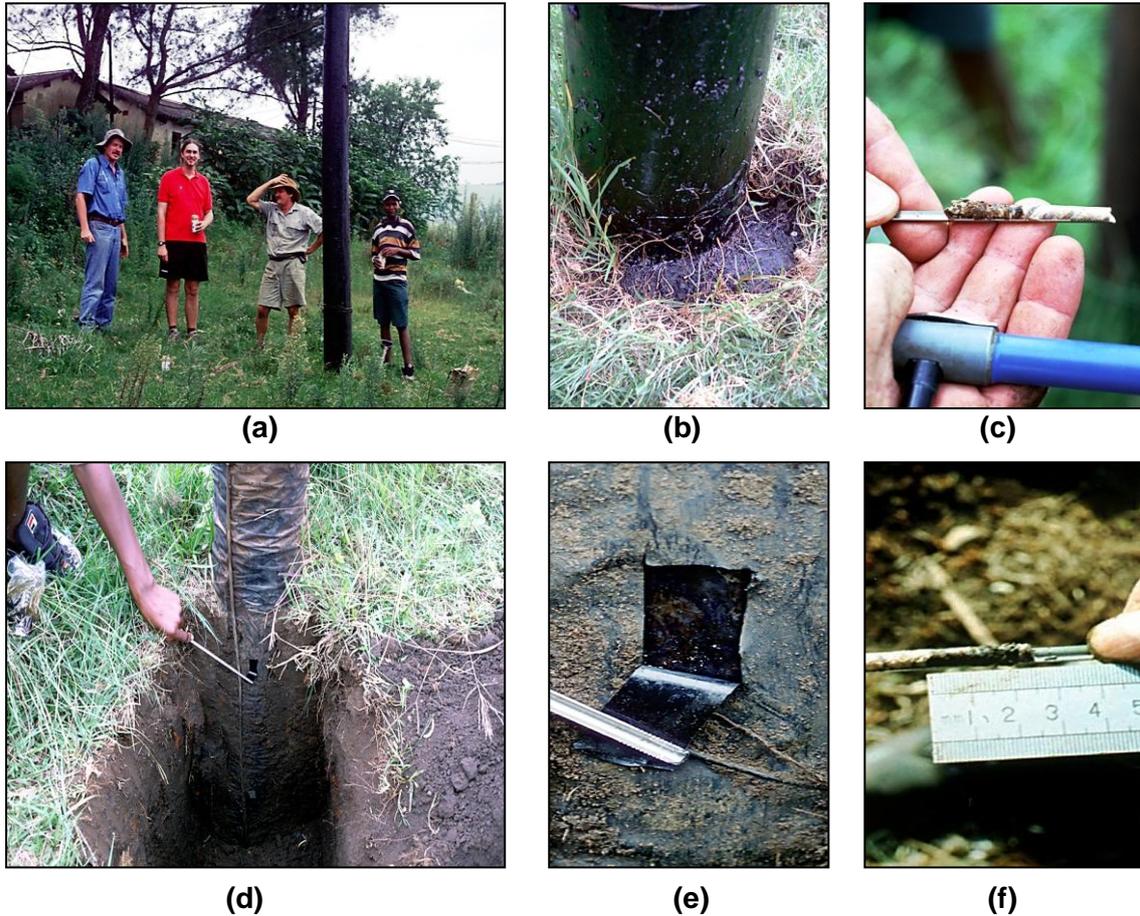
**Fig. 11** Standard pole at Umbumbulu after 1 year's service without BPS (a) leached creosote to the soil (b) and cores taken from the groundline zone showed corresponding losses (c). In contrast excavated substandard poles with BPS (d) showed perfect surfaces when inspection windows were cut (d) and cores taken from the groundline zones (e) showed creosote penetration had increased from 11mm to over 20mm during the first year.

The poles were inspected by this writer with Mr. Barry Hill of Eskom after a year (**Fig. 11**) and it was found that poles without BPS were leaching their creosote to the surrounding soil with corresponding losses obvious in cores taken from the poles. In contrast cores taken from the substandard poles with BPS showed that creosote penetration in the groundline zone had increased to values ranging between 20 – 22mm. This striking trend continued through subsequent inspections (Behr, Shelver and Baecker, 1996, 1997 and chemical analyses of cores at the 4-year stage showed that the creosote retentions of standard poles without BPS had fallen to levels below  $80 \text{ kg.m}^{-3}$  whereas retentions in the previously substandard poles with BPS had increased to levels over the  $130 \text{ kg.m}^{-3}$  (Baecker and Behr, 2000). This trend progressed and at the 6-year stage some of the previously standard poles without BPS were rotting while the previously substandard poles with BPS were in perfect condition (Baecker and Behr, 2003).

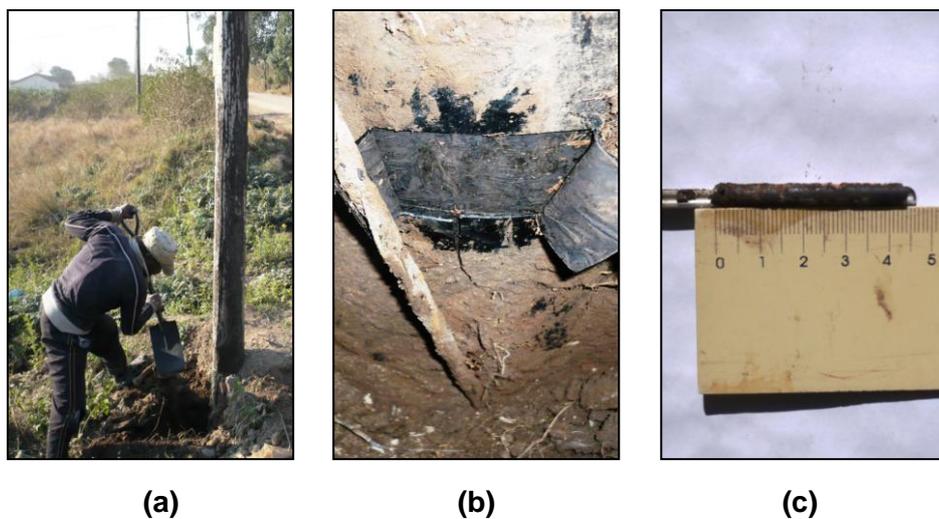
**Fig. 12** Pole with BPS after 15 years' service at Umbumbulu excavated (a) for inspection. Pole surfaces were all free of decay when BPS were opened (b) and cores taken (c) showed that creosote penetration in the groundline zones of all poles with BPS continued to increase

The poles were inspected again at the 15-year stage and those with BPS remained in perfect condition below the groundline (**Fig. 12**) whereas standard poles without BPS were seen to have been replaced.

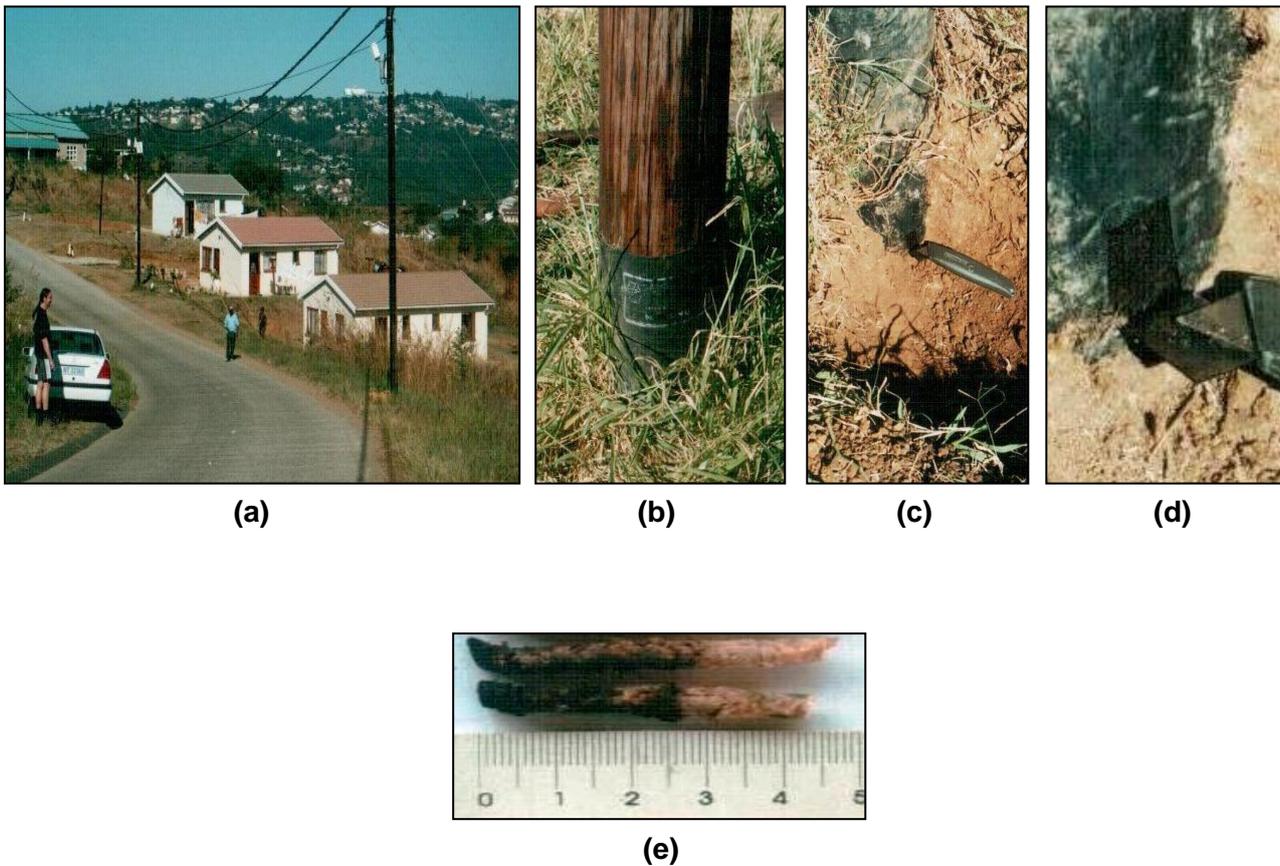
**Fig. 13** A line of electricity distribution poles in service at Newlands West for 6 years (a) with BPS fitted to them (b). All poles were excavated (c) and inspection windows showed all pole surfaces free of decay (d). All cores taken showed creosote penetrations (d) of over 25mm

**eThekwini Electricity** After 6 years' service at Newlands West a line of poles with BPS fitted to them was inspected (**Fig. 13**) in 2002. When sounded by the conventional hammer test all of the poles resonated with the distinctive audible ring that is indicative of sound wood free from

decay. The poles were excavated to examine their subsoil surface areas through inspection windows, and all surfaces were all found to be free from decay. Cores taken from the poles were all within specification and the poles were concluded to be in perfect condition.

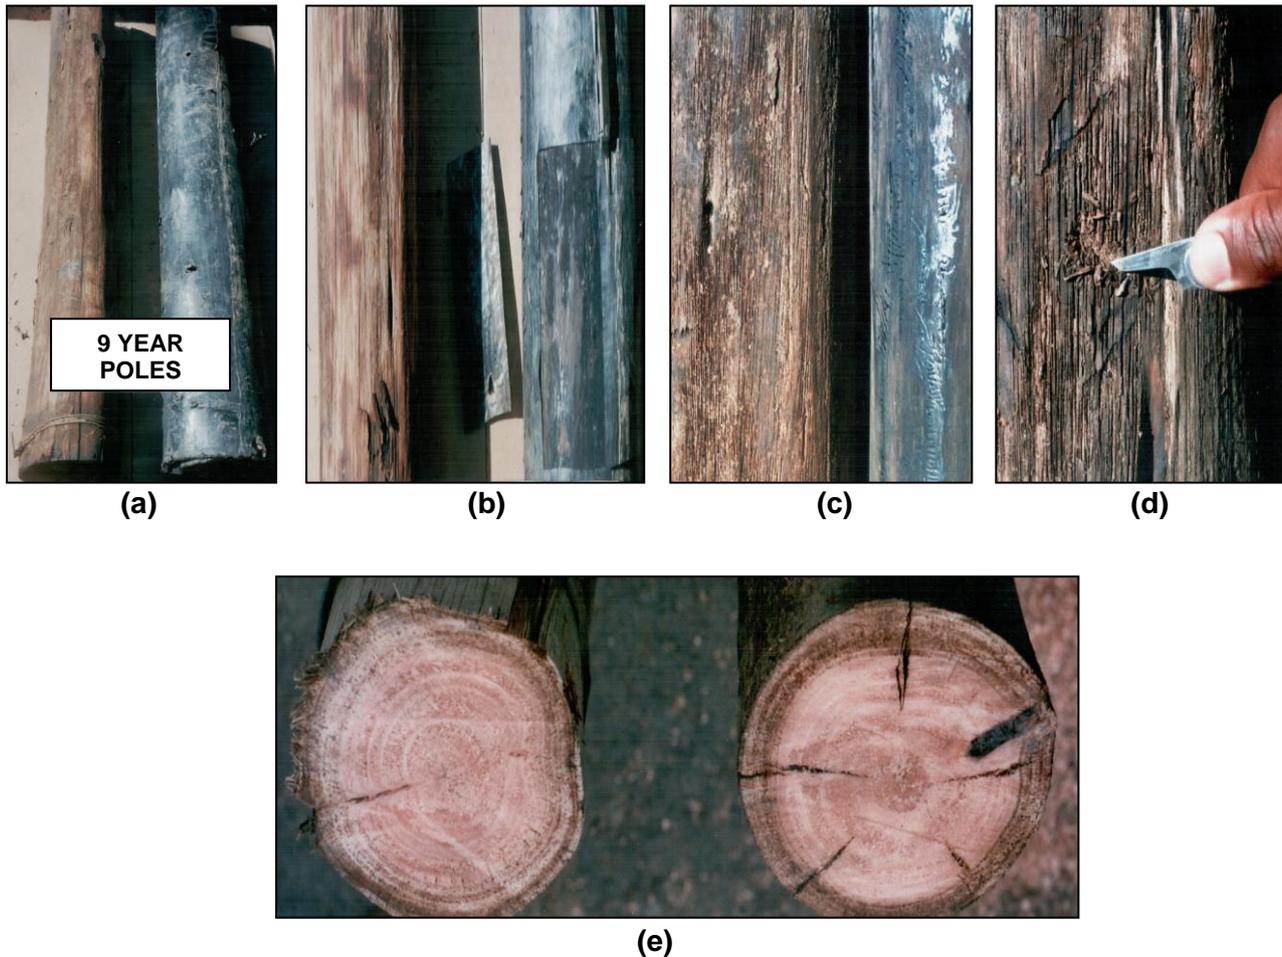
**Fig. 14** The butts of two 11m electricity poles extracted after 9 years' service, one with BPS fitted (**a, right**) and one without (**a, left**). An inspection window (**b**) revealed the pole surface beneath the BPS was free from decay (**b**) whereas the surface of the pole without BPS was extensively degraded (**c**) in the classical pattern of soft rot (**d**). When the poles were sectioned at their previous groundlines it was clear that the pole with BPS (**e, right**) retained significantly more creosote than the pole without BPS (**e, left**) but it was also clear from the spotty distribution patterns of creosote that both poles had been improperly treated while still wet

In 2004 two poles were extracted for destructive tests and examination after 9 years' service in eThekwini Electricity (**Fig. 14**). One pole had been in service without a BPS on it whereas the other had been protected by a BPS. Again, when sounded by the conventional hammer test the pole with BPS resonated with the distinctive audible ring that is indicative of sound wood free from decay, but the pole without BPS did not.

The poles were sectioned transversely at the previous groundline to examine their creosote distributions. In terms of quantity it was clear that the pole without BPS had significantly less creosote at the groundline than did the pole with BPS. In terms of distribution pattern both poles manifested spotty penetration which could only be attributable to incomplete drying before treatment took place. The surface of the pole with BPS was sound and free from decay however, while that of the pole without BPS was extensively decayed. It was clear that the BPS had prevented the onset of decay in the poorly-treated pole it had been applied to.

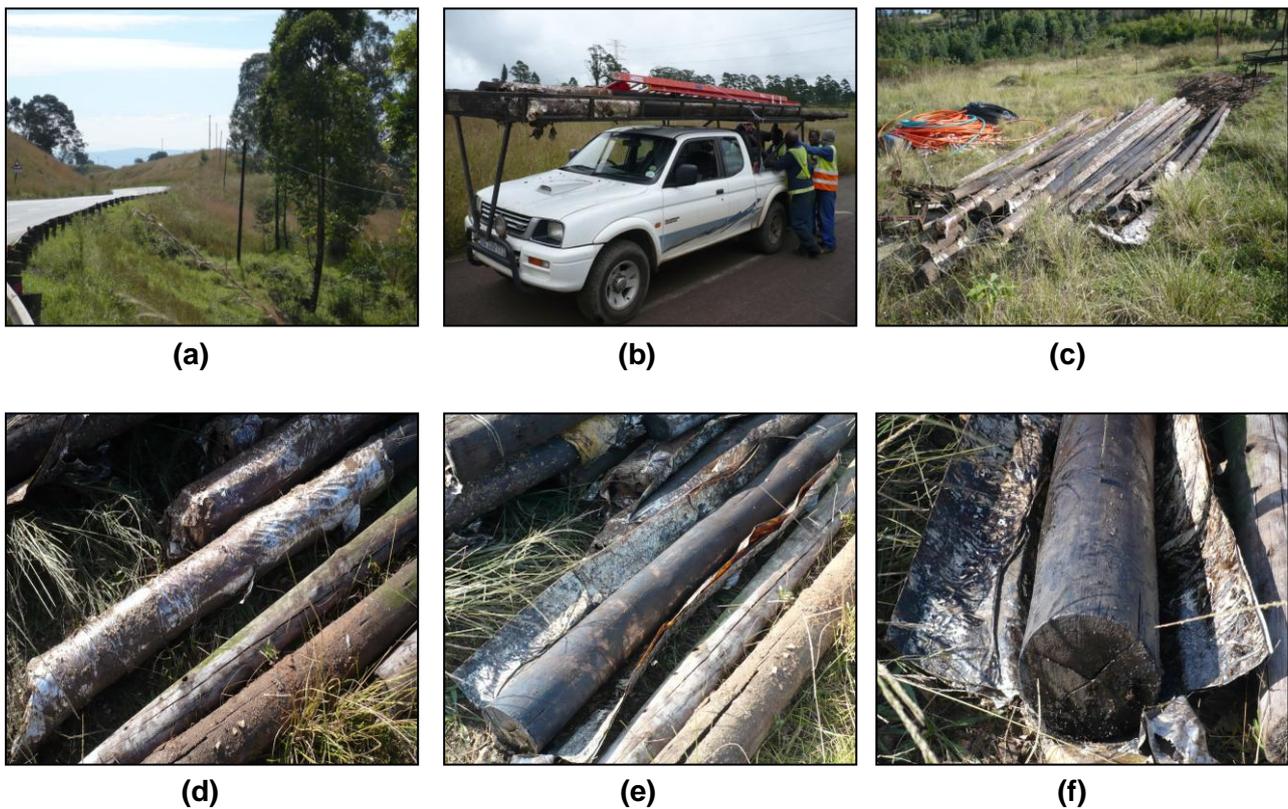
**Fig. 15** A telephone line (a) of 184 green poles fitted with BPS between Thornville and Pietermaritzburg. After 4 years’ service all poles were extracted (b) and stockpiled (c) for inspection. When BPS on the subsoil regions (d) were opened (e) all wood surfaces were sound (f) and free from decay.

green at 55 – 60% moisture content. Biotrans Pole Sleeves were then fitted to the poles and they were used to install an overhead telephone line between Thornville and Pietermaritzburg in South Africa. Apart from inoculating the poles with decay fungi before putting them into service it is hard to imagine a more rigorous test of the BPS’s ability to keep a pole sound. The BPS were even punctured during backfilling, and veldt fires burned much of the surrounding vegetation every year. The BPS survived the fires because the flames and heat of such fires exert their major temperature effects well above the groundline. Four years later all the poles were extracted and examined to establish whether the BPS had performed differently from any other cases reported here.

When the BPS were opened the subsoil surfaces of all poles were in pristine condition (**Fig. 15**), free from any form of decay, and the creosoted surfaces seemed fresh to the senses of smell and touch. When the lower ends of the poles were sectioned longitudinally (**Fig. 16**) it was clear that the pattern of creosote distribution was typical of improperly-treated wet wood. Solid penetration never exceeded 3mm and the overall depth of solid plus spotty penetration never exceeded 13mm above the groundline in any pole. However, in terms of BPS performance two striking observations

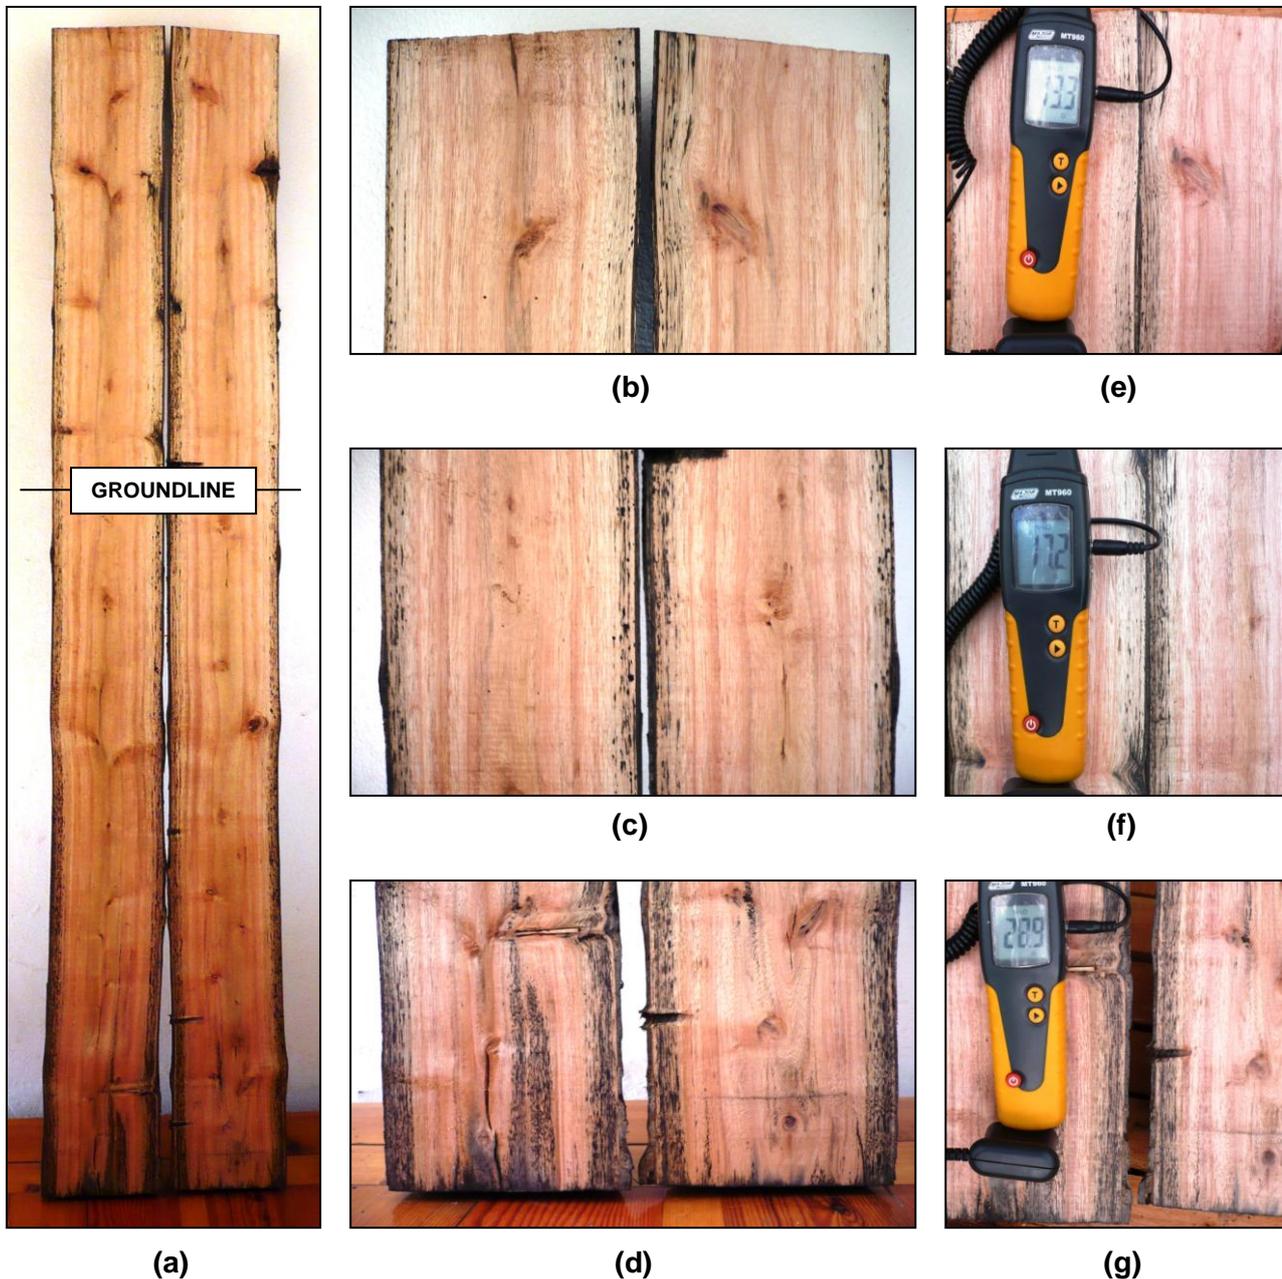
**Fig. 16** Longitudinal sections (a) of a pole treated with creosote while “green” and put into service for four years with BPS fitted. Creosote distribution was sparse as expected but increased downwards from 1 metre above the groundline (b), through the groundline (c) to maximum concentration at the butt (d). Moisture content of the pole had fallen below 14% above the ground (e) to below 20% in the groundline zone (f) and below 30% at the extreme end (g) of the butt

were made, viz., (i) the creosote concentrations in the butts were all greater than above the groundlines and (ii) the moisture contents in the butts had fallen from the original levels of 55 –

60% at which the poles were installed to less than 20% at the groundline and less than 30% at the extreme ends of the poles.

The observation that creosote had concentrated in the butts of creosote-treated poles with BPS was totally consistent with all previous studies in this field. The fact that the moisture contents of poles with BPS are lower than poles without BPS is also fairly well-known but the actual reason for that phenomenon is less well-known because the Institutions to date that have proven this fact have all done so in the course of confidential studies for third parties (e.g., studies mentioned at committee meetings in North America when the AWPA approved BPS in Standard AWPA-P20). However, it is now accepted logic that a wet wooden pole with its butt inside an encapsulating BPS in soil is analogous to a flower in a vase of water and transpiration will rapidly deplete the water from the vase or the BPS. This logic explains perfectly the above observations particularly when it is borne in mind that the BPS used were totally impervious to water which could not therefore diffuse into the butts to replace that water which was transpired from the butts to the surrounding atmosphere by the poles.

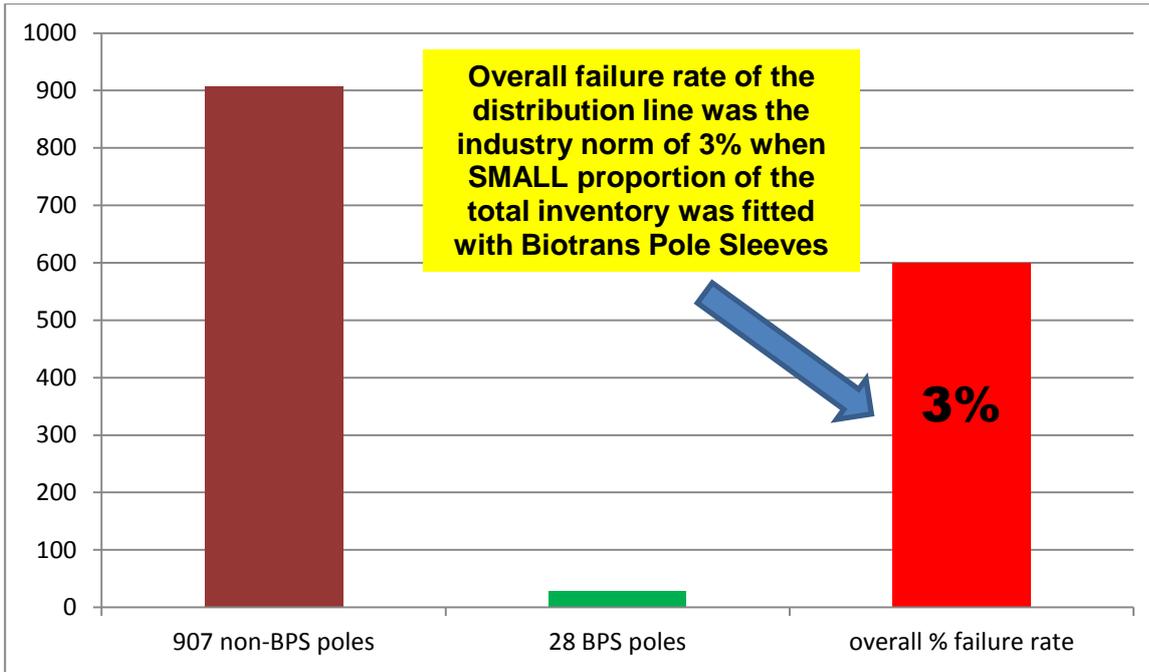
**Figure A:** Eskom-approved inspectors' findings in 2005 on Richmond Beaumont NB 63 distribution line after 10 years' service: overall failure rate among all 935 poles was 3% (although the failure rate among the 28 BPS poles was 0%)

In 2005 two of the Umbumbulu distribution lines containing BPS poles were then independently inspected by Eskom-approved pole inspectors and those findings confirmed that all but one of the previously-substandard BPS poles had become Class 1 poles (i.e., they were within Specification and required no remedial treatment) during the ten-year inspection cycle. Specifically, **Fig. A** shows the analysis of the inspectors' results for the Richmond Beaumont NB 63 distribution line, which had 907 non-BPS poles and 28 BPS poles in it. The overall failure rate of this line was 3%, all of which poles were previously Standard non-BPS poles. In contrast, **Fig. B** shows the analysis of the same inspectors' results for the Richmond Beaumont NB 22 LV distribution line, which had 110 non-BPS poles and 190 BPS poles in it. The failure rate among the previously Standard non-BPS poles was the normal 3%, however the overall failure rate of the whole line was only 1% because approximately two thirds of the poles in it were BPS poles that had become Class 1 poles during the ten year service period. These findings prove categorically that BPS usage slashed the normal pole failure rate when mixed with non-BPS poles, in spite of the fact that the non-BPS poles were all Standard ones while the BPS poles were all substandard ones when the distribution lines were erected in 1995.

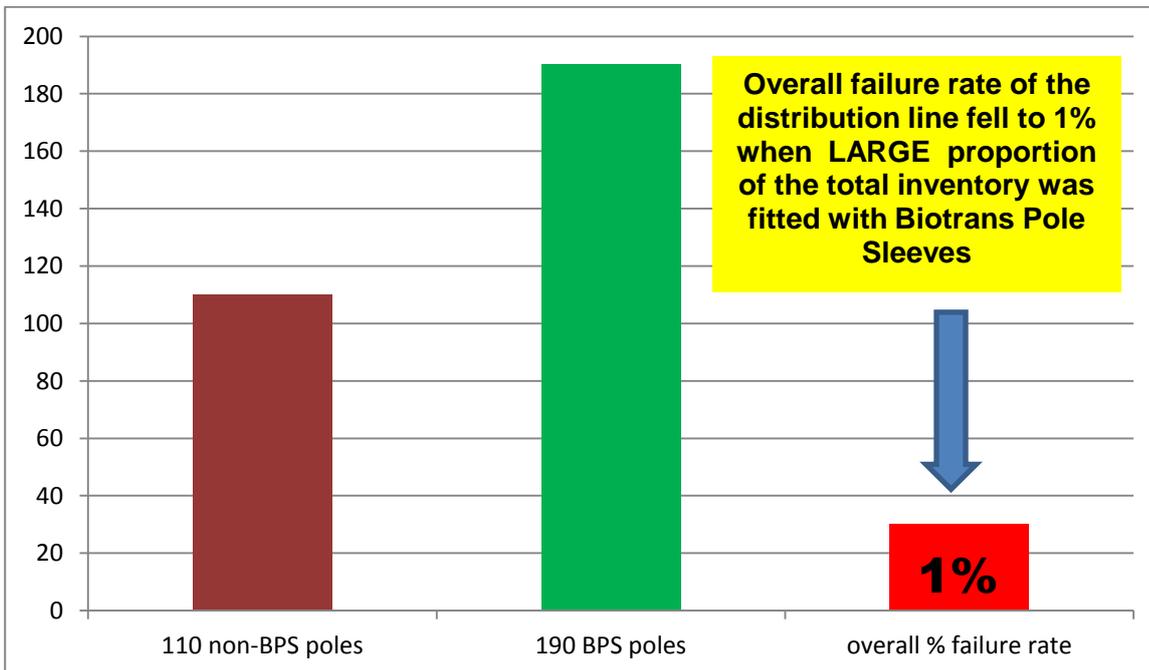
**Figure B:** Eskom-approved inspectors' findings in 2005 on Richmond Beaumont NB 22 LV distribution line after 10 years' service: overall failure rate among all 300 poles was 1% (although the failure rate among the 110 non-BPS poles was the normal 3% while among the 190 BPS poles only 1 of them had not become a Class 1 pole)
