A Non-toxic Method to Combat Incipient Decay of CCA- and Creosote-Treated Poles in Soil-Contact

A. A. W. Baecker

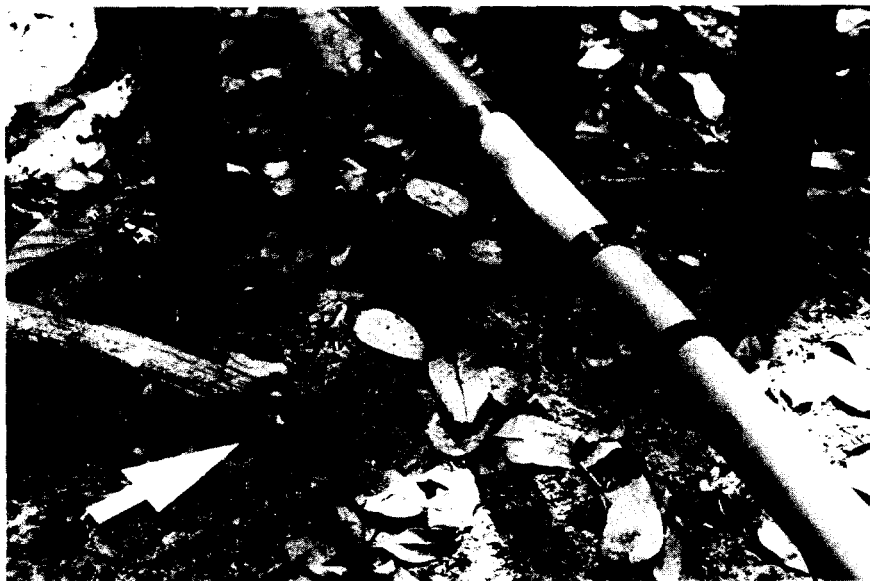
Fig. 1. Poles in soil contact at the test site after exposure to flood irrigation for 26 weeks. An untreated unsleeved pole had failed and collapsed at the point arrowed.

At the end of the 26-week exposure, the untreated unsleeved poles had failed and collapsed owing to decay below the ground line (Fig. 1). On
